Manhole Inspection Summary

Manhole # S31EE2004MH

Insp Date: **11/30/06 1:22 PM**

Location Address: **5703 AINSLEY GRTH**

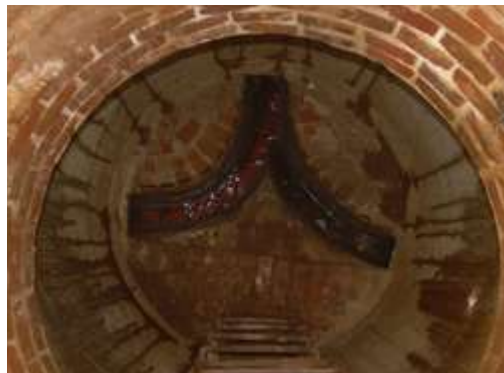
Top View

Evidence of surcharge - Bench debris.

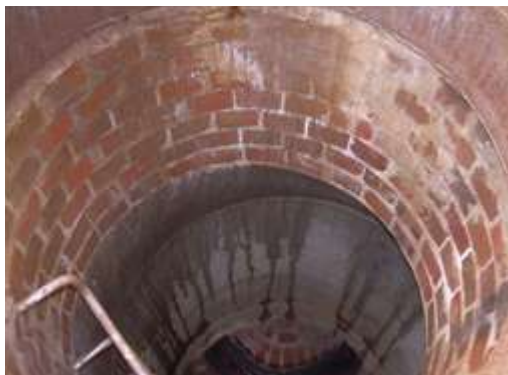
Defect

Frame leaks. Adjustment and Corbel infiltration - other side.

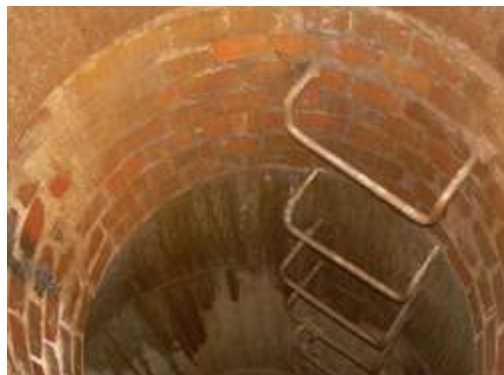
Defect

Frame leaks. Adjustment and Corbel infiltration.

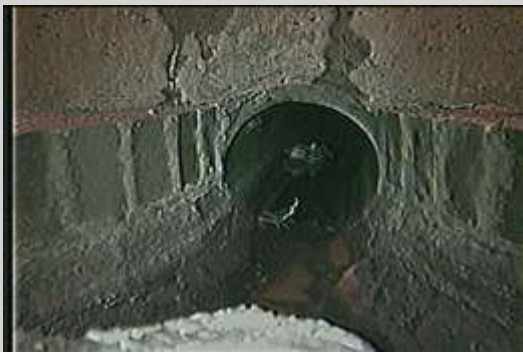
8 in. Circular Gravity Sewer Pipe Out @ 12 O'Clock

Infiltration: **Evidence** Pipe Seal Cond: **Unknown**

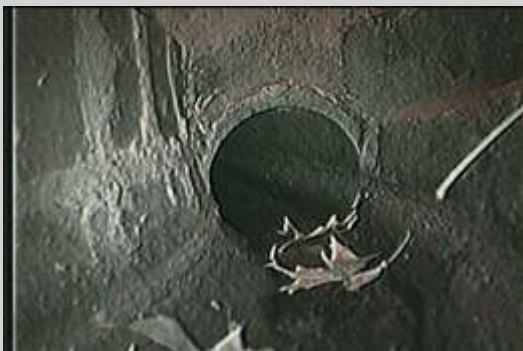
6 in. Circular Gravity Sewer Pipe In @ 4 O'Clock

Deposits: ☐ None ☐ Mud ☐ Sludge ☐ Debris ☒ Grease

Silt Depth: **0** (in.) Deposits Extent: **Light**

Infiltration: **Evidence** Pipe Seal Cond: **Unknown**

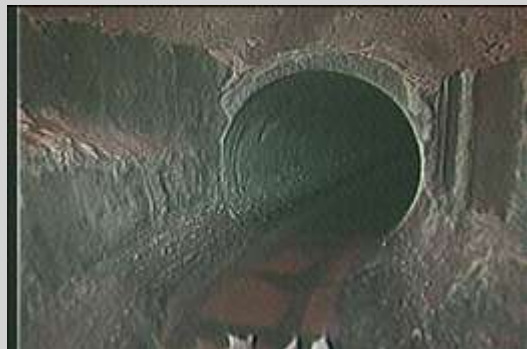
Pipe In @ 9 O'Clock

Deposits: ☐ None ☐ Mud ☐ Sludge ☐ Debris ☒ **Grease**

Deposits Extent: **Light**

Infiltration: **Evidence**
